Performance Assessment of a Roadway Bridge Under Seismic Events

Thesis submitted in partial fulfillment for the degree of Bachelor of Civil Engineering

Universidad Industrial de Santander

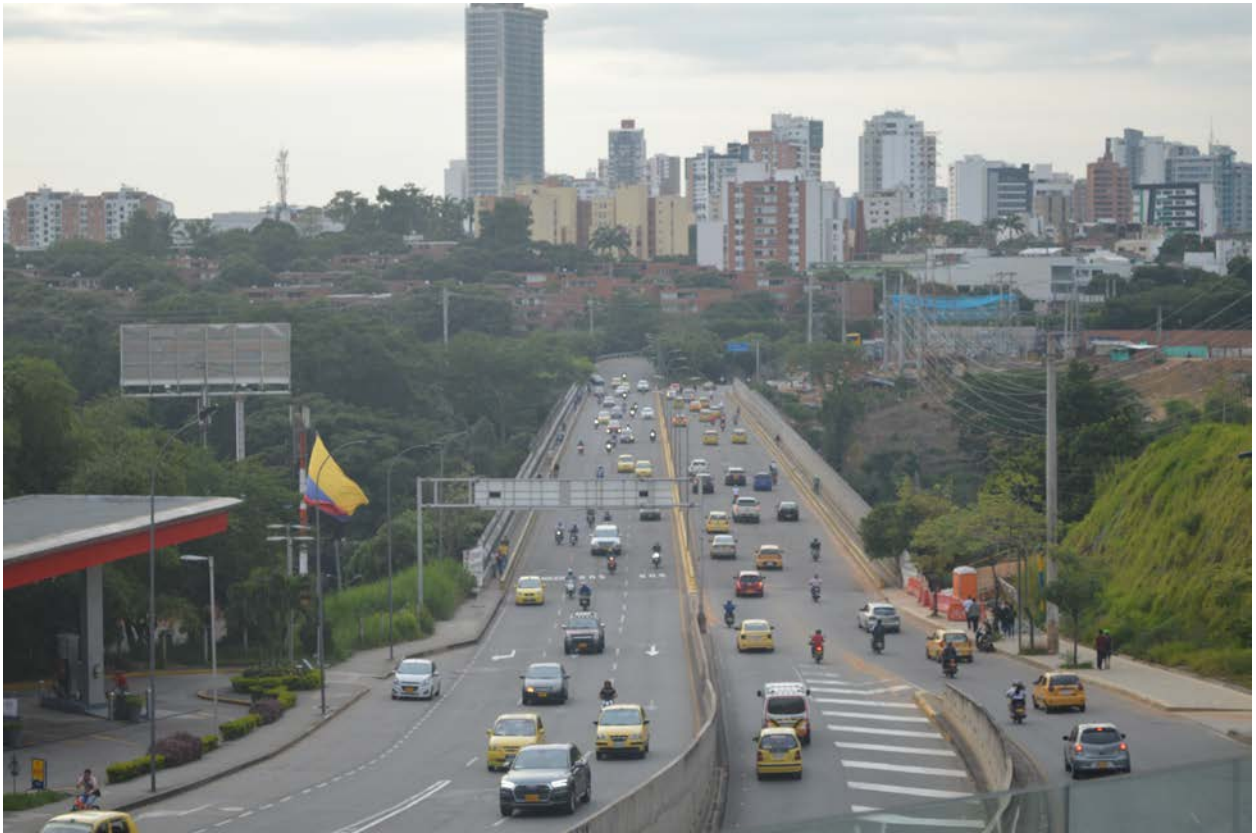
The viaduct “La Flora” is a nine-span girder bridge located in Bucaramanga, Colombia (see Figure 4). The bridge has 298.3m of total free length between abutments (see Figure 5), a deck width of 25m, with 3 lanes for each roadway. The deck is supported by 91 girders with a height of 1.63m (see Figure 6), that are distributed on the nine spans of the bridge. The substructure is composed on each axis by two 4x3m piers, that are connected to a cap beam with 2m of height and 3m width (see Figure 7).

Figure 4. Case study: “La Flora” bridge.

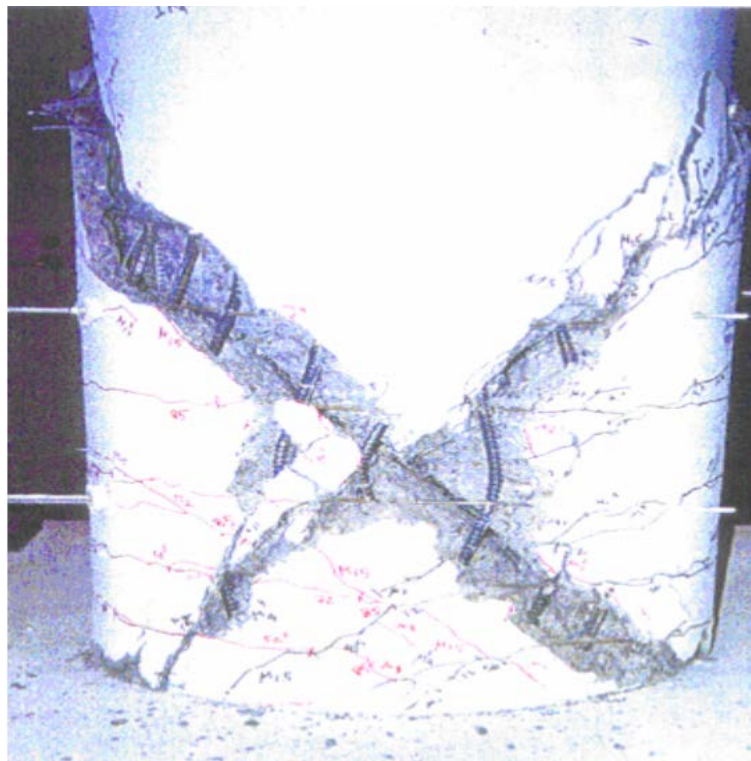
*Figure 9.* Diagonal crack (plastic hinge region-base). Adapted from Caltrans, (2006).

Piers designed between 1971 and 1994, develop the yield moment of the section but degrade after repeated cycles due to degradation of concrete shear strength within the plastic hinge, leading to the shear failure of the hinge (see Figure 9) (Caltrans, 2006).

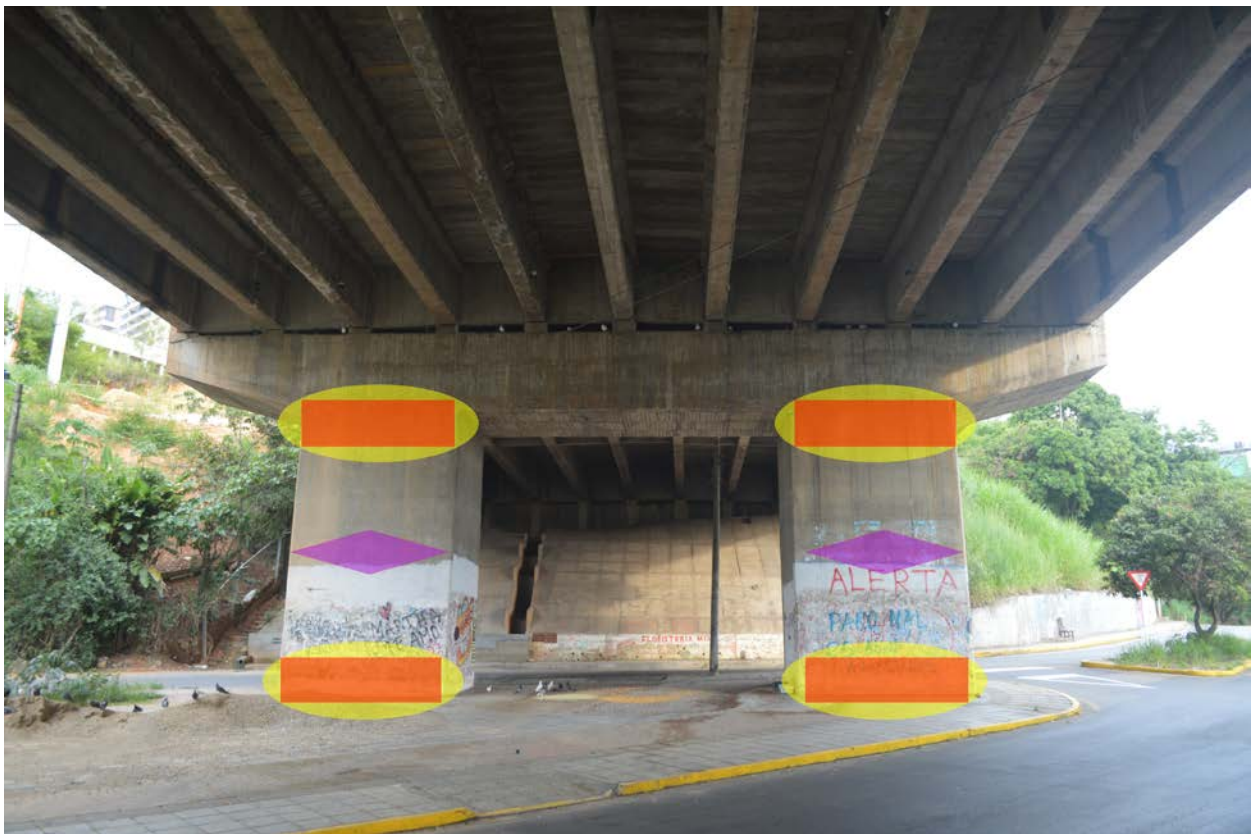
Figure 10 shows the critical zones of the shortest pier, in which the yellow ovals represent the place where is most likely to present bending failure, the red rectangles represents the places where

probably the pier is going to present shear failure, and the purple rhombus represent buckling (Hajdin et al., 2018). Due to the small height of the pier in comparison with its cross section, buckling is the less likely. The bottom of the pier is going to be the most vulnerable zone of the bridge due to the high concentration of the base shear.

Figure 10. Critical zone of the case study

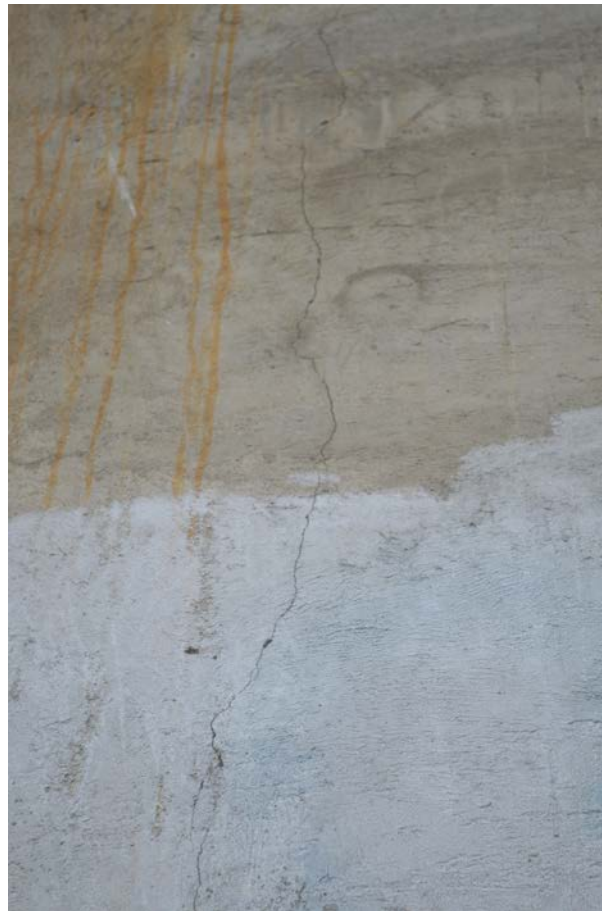
Some smaller cracks were detected on the pier; these defects have a thickness of less than 0.5 mm. Are most likely a result from the construction process (shrinkage cracks) and doesn't represent any reduction in load-bearing capacity, serviceability or durability (Stipanovic et al., 2017).

*Figure 23. Small crack detected on the pier.*

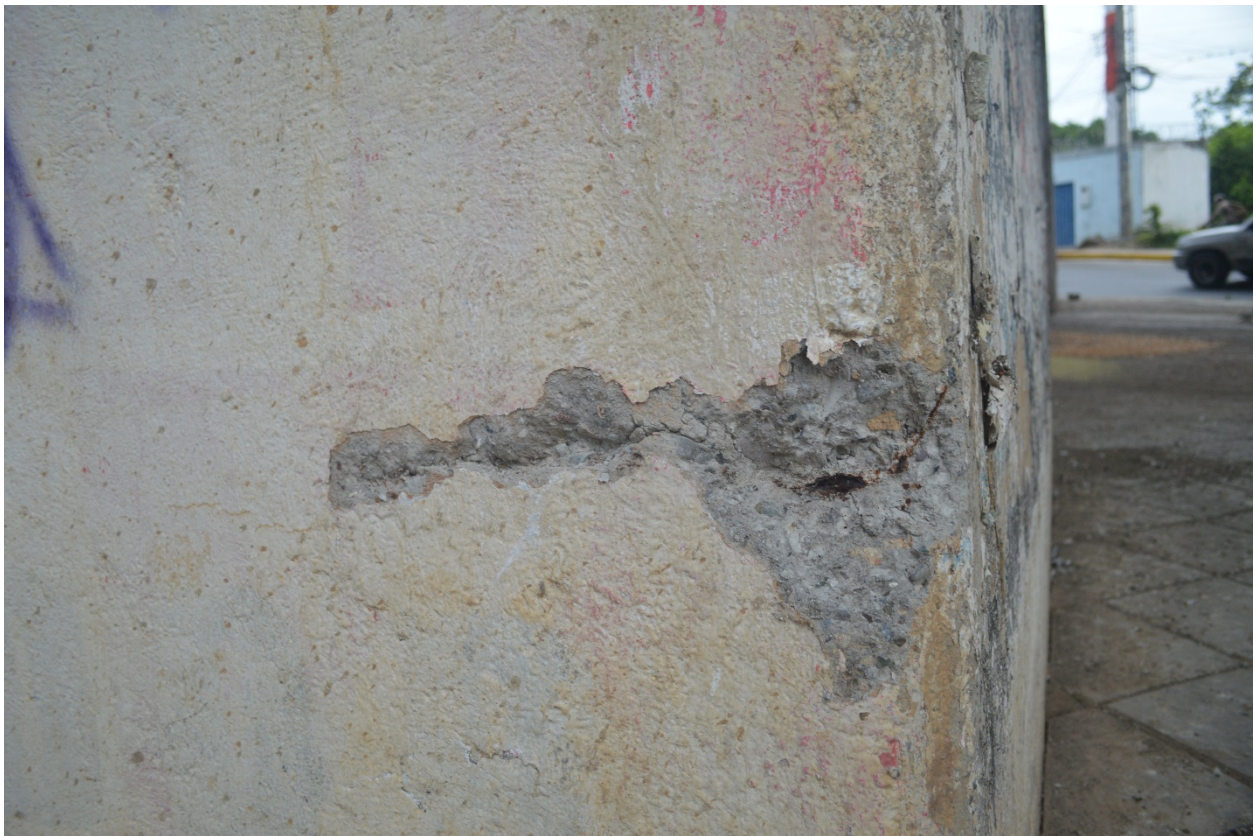
Damage at the base of the pier was detected. Nonetheless, the defect is most likely due to an external factor like an impact which allows the degradation of the concrete and the corrosion of the transverse reinforcing steel. Minor or light damage such as the one shown in Figure 24, have no impact on the load bearing capacities of the structure (Stipanovic et al., 2017).

*Figure 24.* Environmental defects detected on the pier.
